Updated Flood History, Great Brook Watershed, Plainfield, Vermont

May 12, 2015

Prepared for the
Plainfield Flood Committee

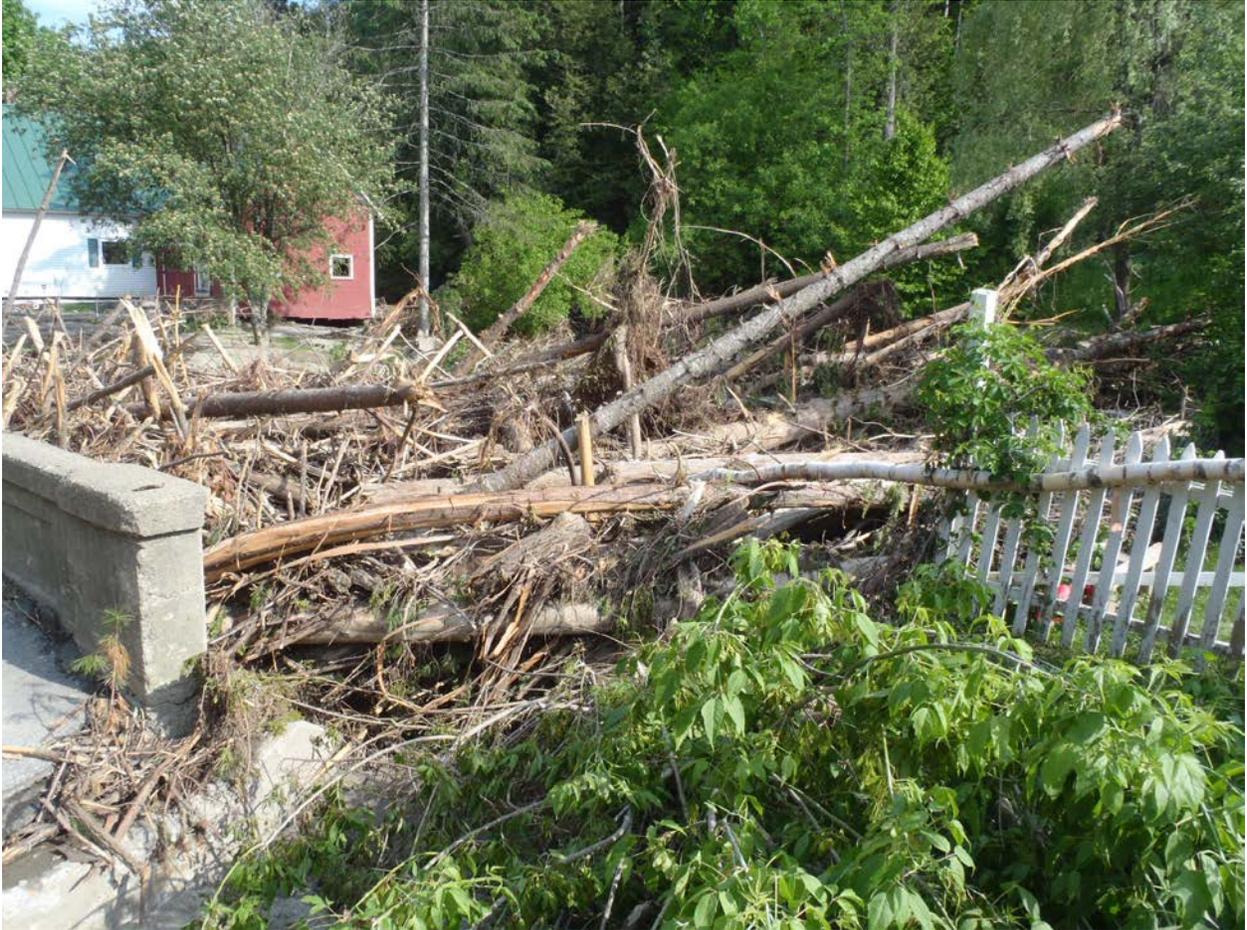
On the cover: Photo of debris jam formed during flood of May 26-27, 2011 at bridge on Great Brook in Plainfield village. Photo taken on May 31, 2011 looking upstream from left bank.
