**Central Vermont Regional Planning Commission
Town of Plainfield**

**Pedestrian Bridge & South Sidewalk
Conceptual Alignment Analysis**

Existing Conditions

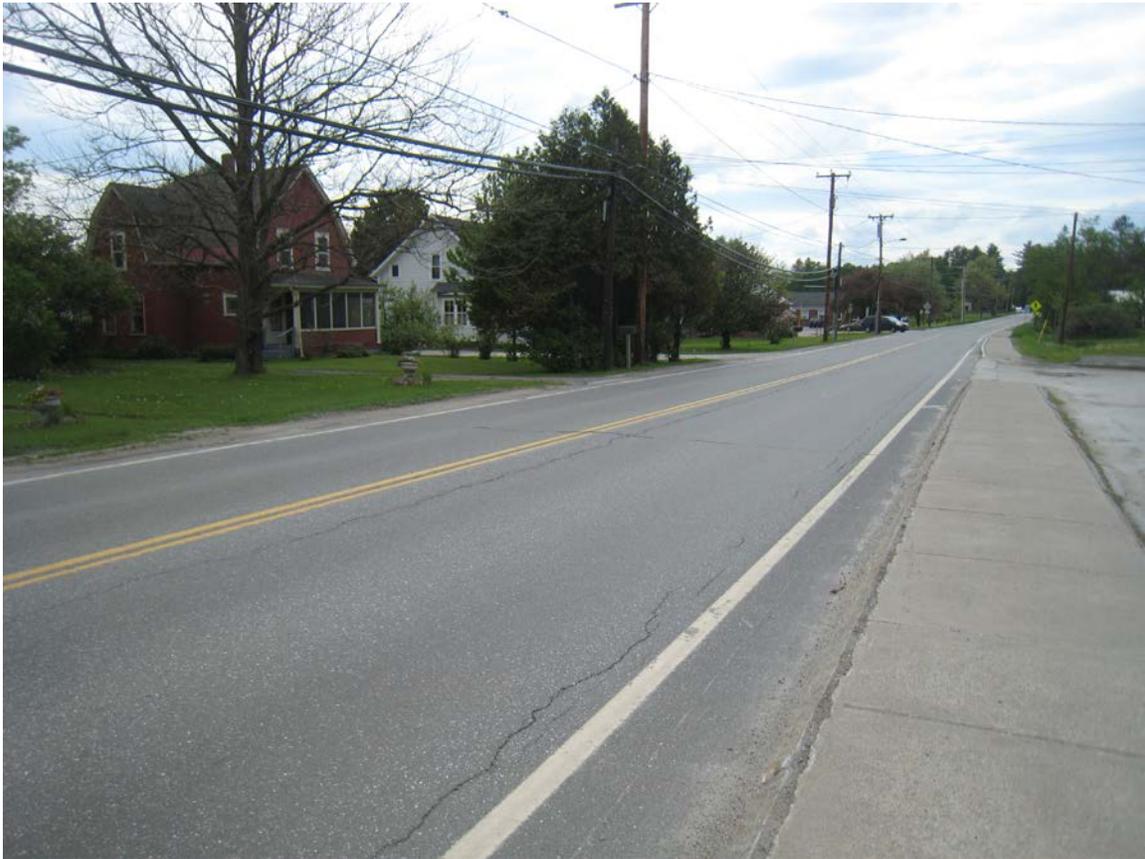
On the western end of the Study Area, Route 2 consists of two 12-foot travel lanes with one-foot paved shoulders on either side of the road for a total paved width of approximately 26 feet. A curb and sidewalk also line the north side of the road. Approximately 100 feet east of the west intersection with Towne Road, the north paved shoulder widens to three feet wide; the south side paved shoulder remains one foot wide. The total pavement width at this point is approximately 28 feet. At the bend in the road just west of the Cutler Library, the north side shoulder gradually narrows back to one foot wide. The pavement width narrows to 25 feet wide. The curb and sidewalk continue eastward on the north side of the road to the intersection with Main Street near the eastern end of the Study Area. A gravel shoulder varying in width from one to approximately three feet lines the southern side of the roadway.

Looking west on Route 2; the narrowing of the paved shoulder from three feet to one foot can be seen just past the driveway entrance on the right side of the road.

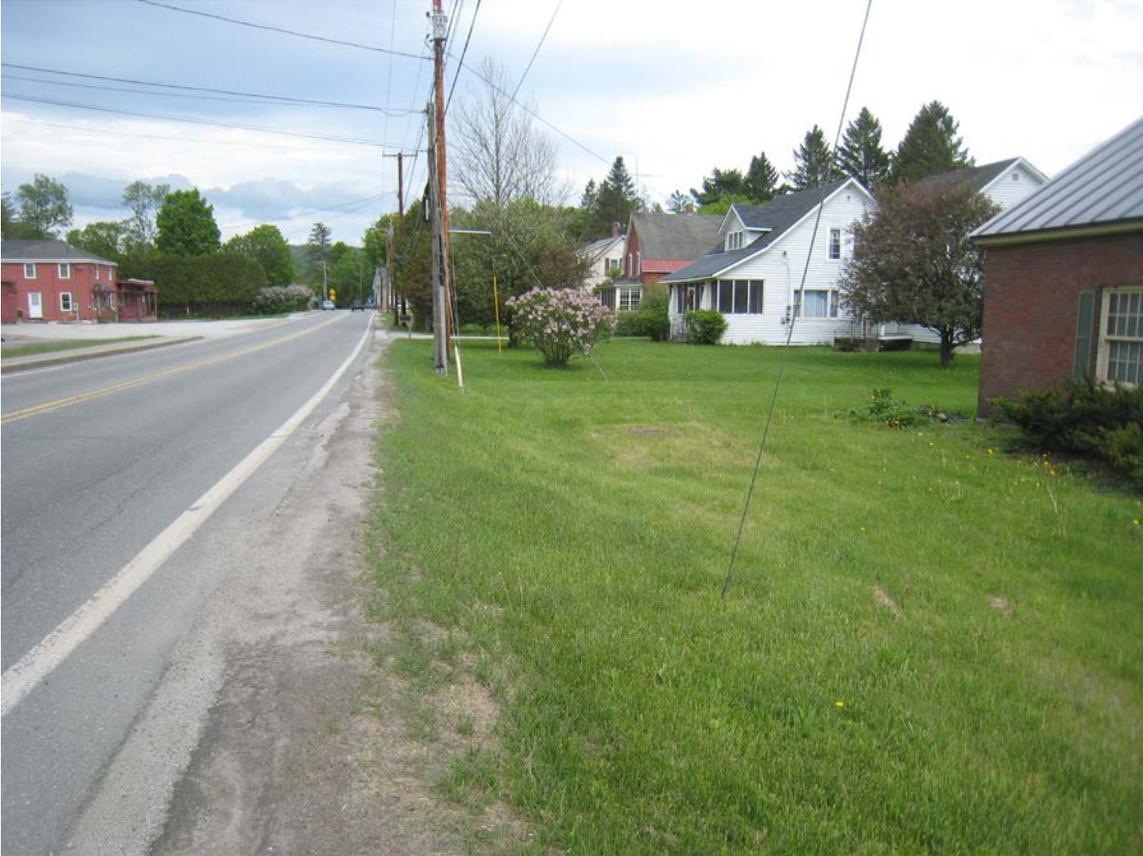
The roadway is relatively level with a grade larger than ten percent for a short distance near the intersection with Main Street. There are very small slopes along the south side of the road just to the east of the western intersection with Towne Road heading down and away from the gravel shoulder. The adjacent land at the edge of the right-of-way is approximately three feet lower than the roadway surface. There is another slope relatively close to the road in the large gap between existing buildings on the south side of the road. This slope heads all the way down to the Winooski River, with a drop of approximately 50 feet. There are no guardrails along the sides of the road in the Study Area.

Looking east on Route 2 in front of the FairPoint building showing the drop in grade.

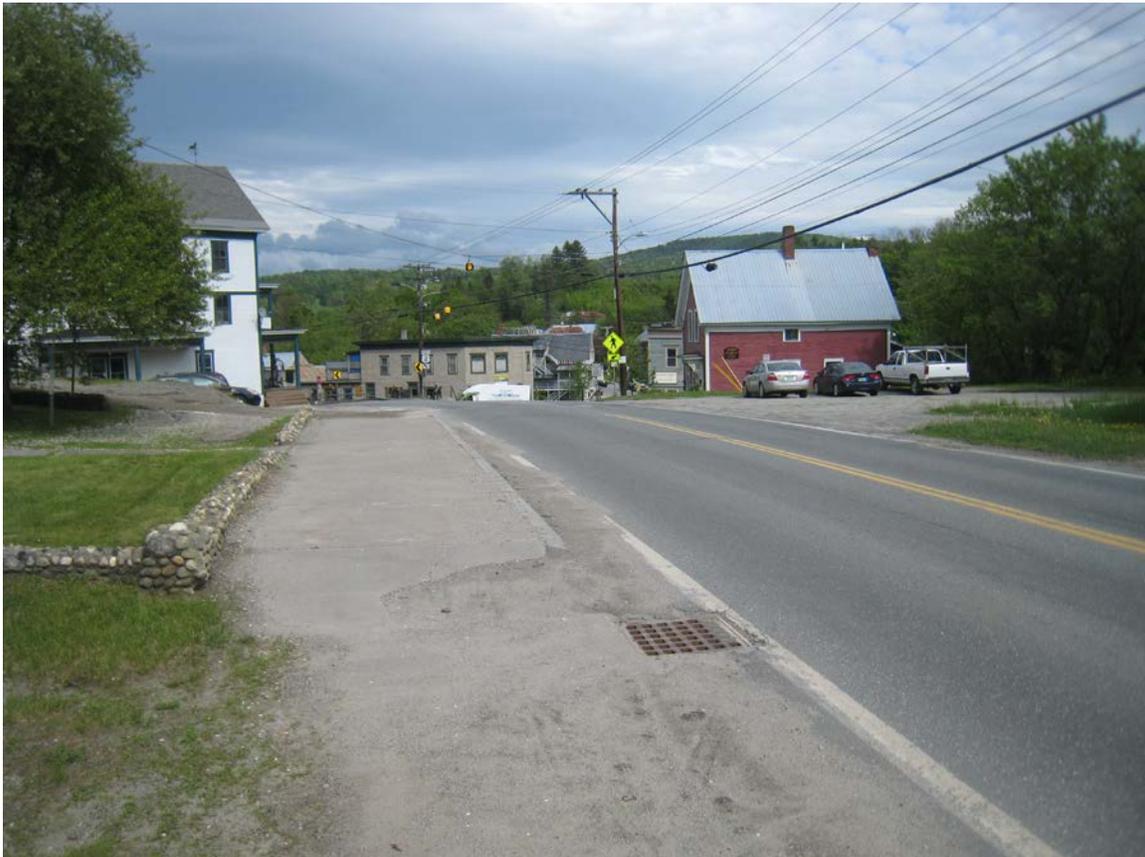
The intersection with Main Street is not signalized but does have a single blinking yellow light facing Route 2 and a single blinking red light facing Main Street.

Looking east on Route 2 towards the intersection with Main Street; the blinking yellow light can be seen just above the tree line. A crosswalk warning sign is also visible on the right.

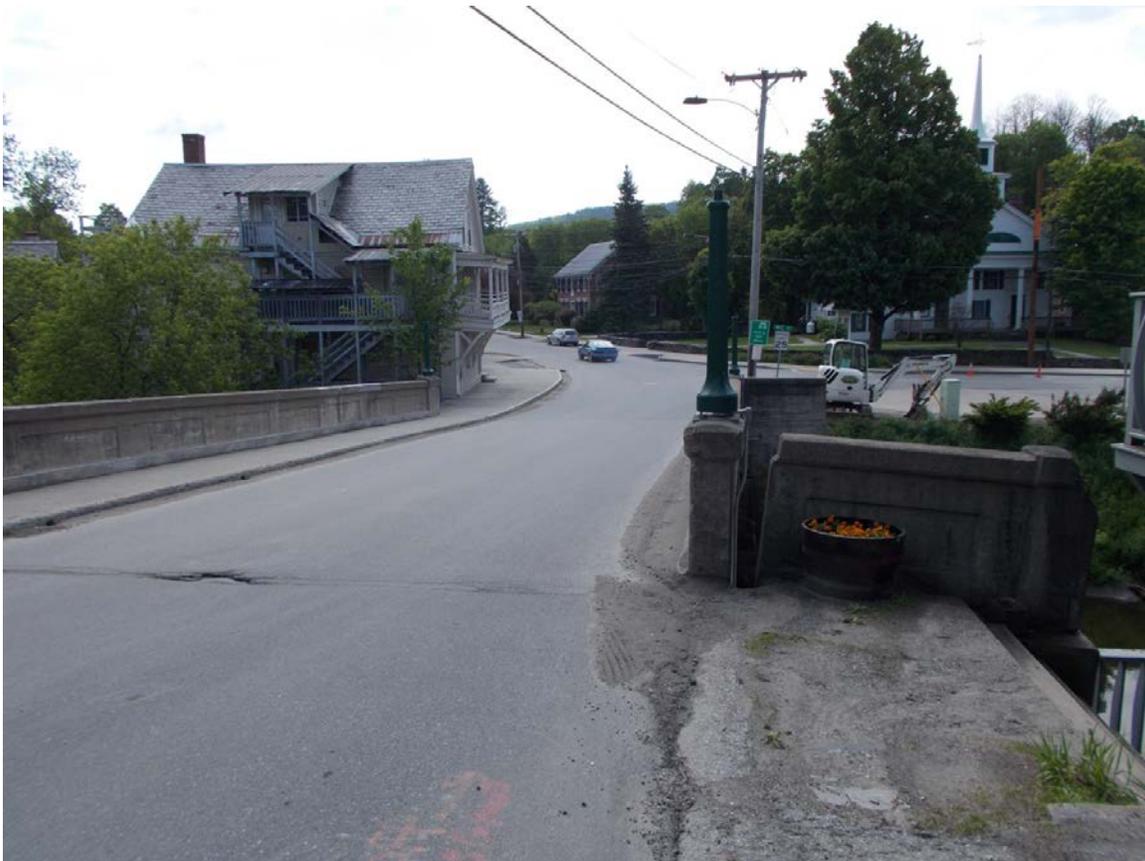
Bridge 27 is a 60-foot single span concrete tee beam bridge that was built in 1927. The bridge carries Main Street over the Winooski River and has a curb-to-curb width of 26.5 feet. The bridge also carries a 5-foot-wide sidewalk of the north fascia. There appears to be a sidewalk cantilevered over the southeast wingwall that terminates at the bridge. The structure has concrete panel railings with new street lights mounted to the top of the railing. A VTrans inspection report indicates the superstructure is in satisfactory to fair condition. The substructure appears to be a dry-laid stone masonry abutment in satisfactory condition. Notes from the BRPD Team site observation show deterioration along fascia tee beams, cracking, spalling and delamination of the concrete on both the ridge deck and beams. The bridge's federal sufficiency rating is 84.5 of a possible 100 points. Illustrations show the bridge configuration and provide a sense of the condition.

Looking east along Main Street.

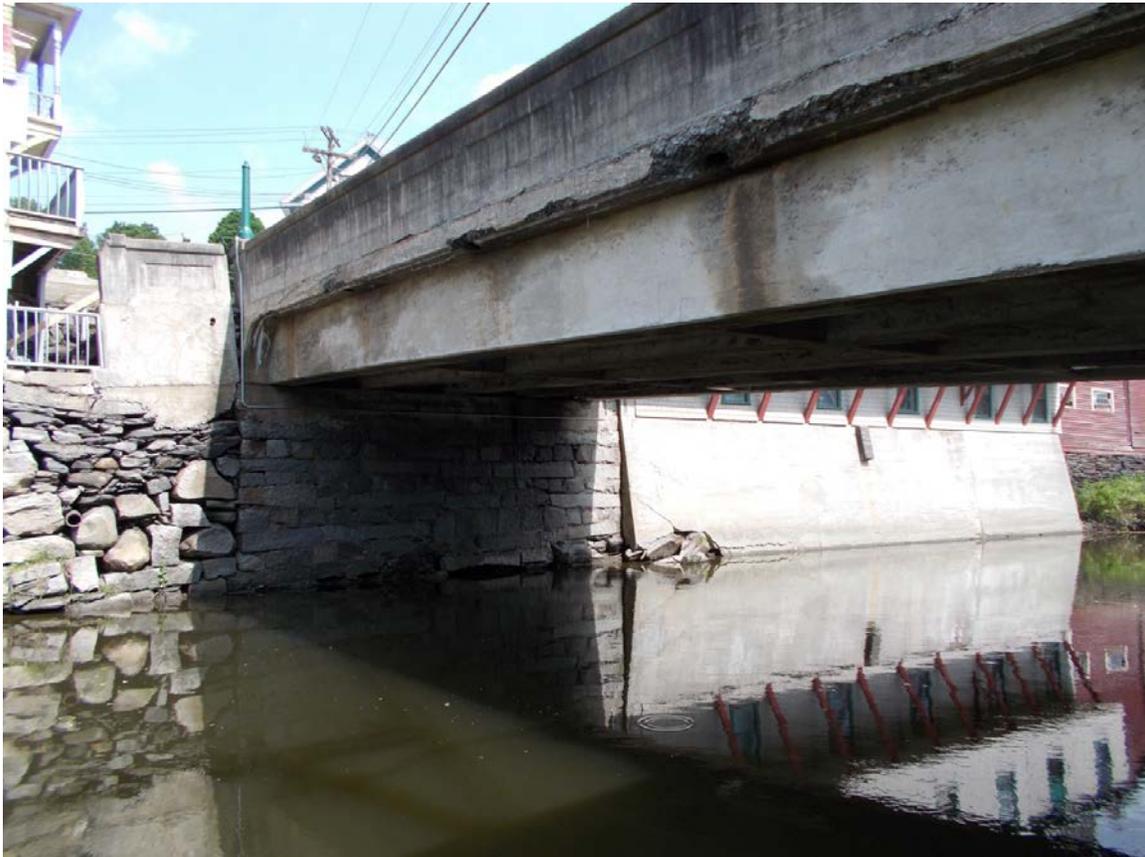
Looking under the bridge from the south side showing the west abutment and the south bridge fascia

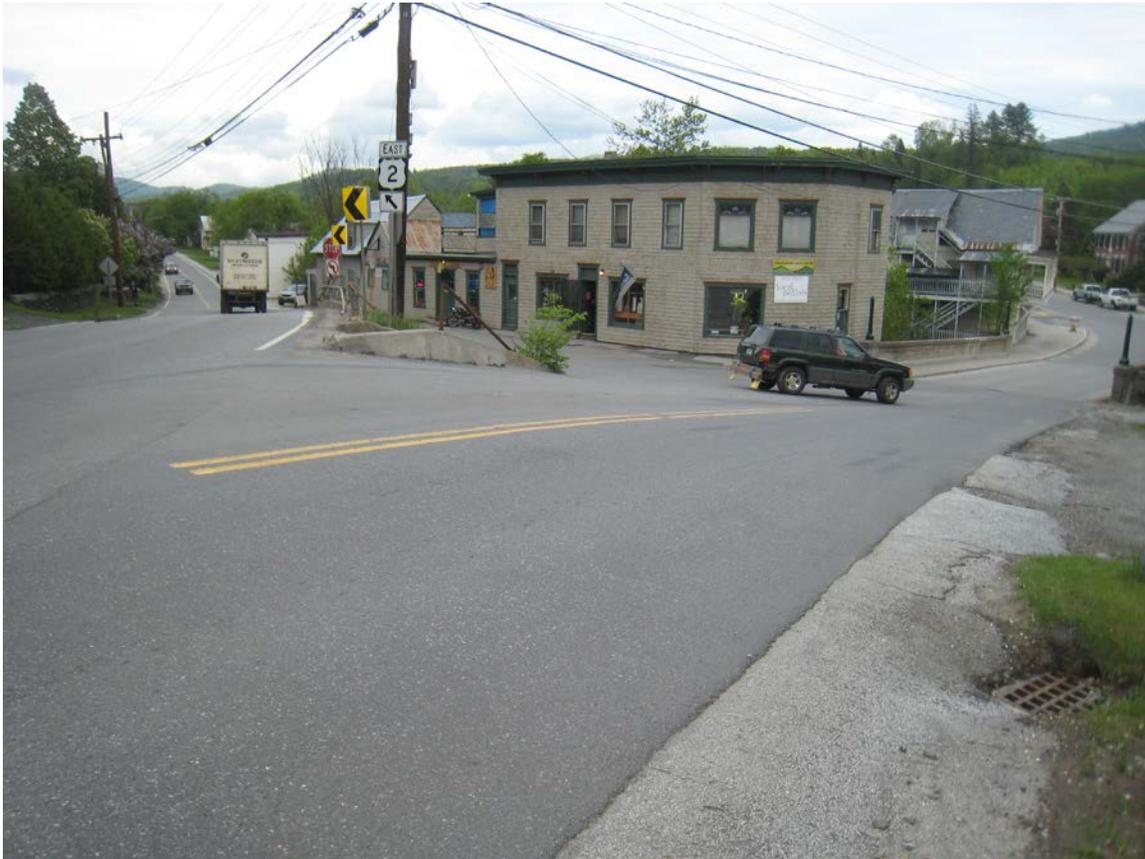
The topography in the Study Area is generally level in the immediate vicinity of Route 2 but drops significantly towards the Winooski River behind the buildings fronting on the east side of Route 2. The drop is visible on Main Street as it descends towards the bridge from the intersection with Route 2. **Figure EC-2** shows the general topography in the Study Area. The drop to the Winooski River comes close to the edge of Route 2 in the gap between the buildings to the east of the Cutler Library, close to the location where there are large logs stored adjacent to the road.

Looking south towards the bridge over the Winooski River; the drop in the road is evident in the photo. Route 2 continues east on the left side of the picture.

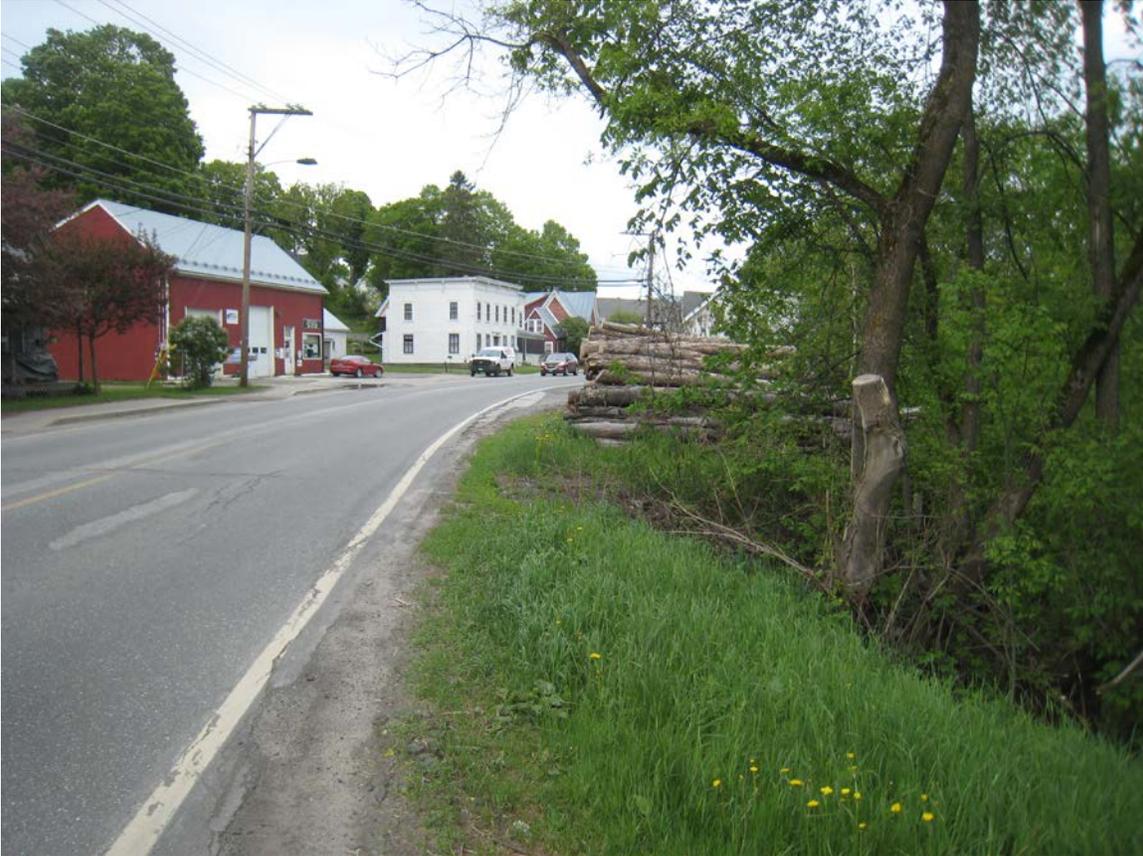
Looking east on Route 2 with the steeply sloping area down to the Winooski River shown a few feet away from the pavement.

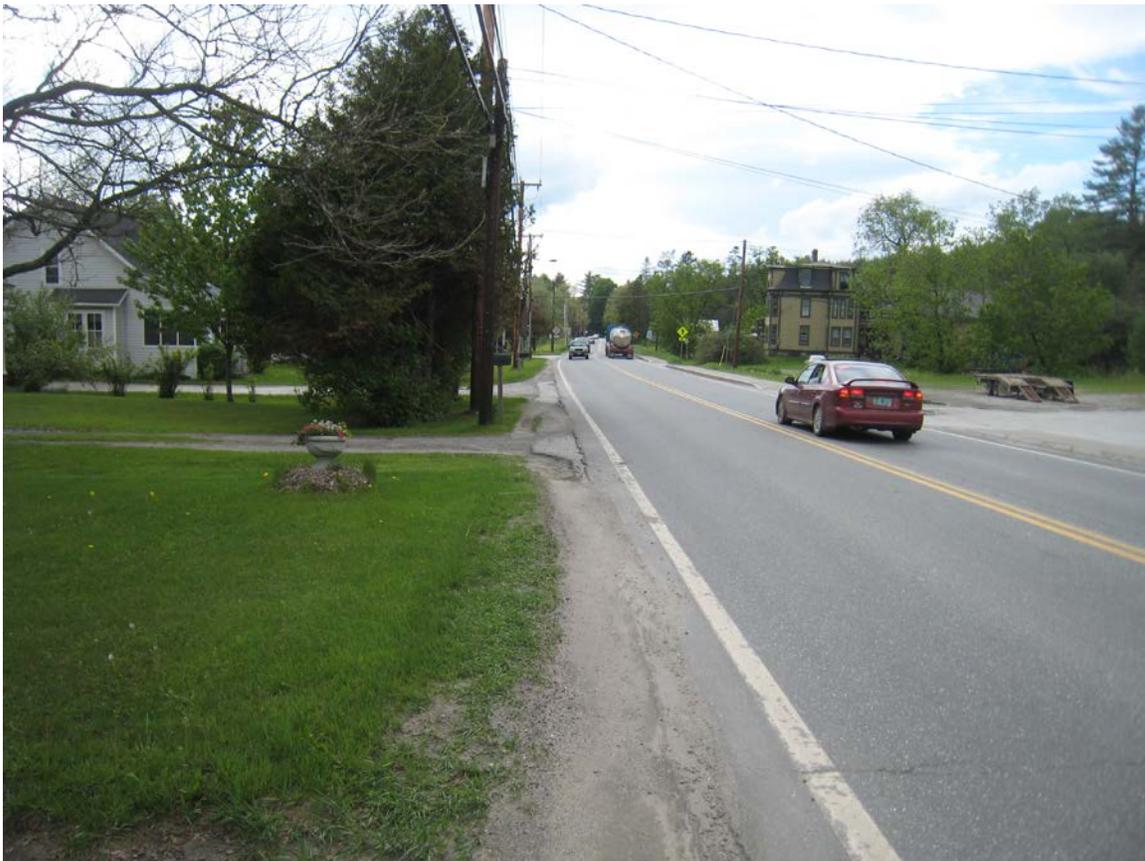
There are several large trees located in or close to the Route 2 right-of-way. **Figure EC-2** shows the location of these trees. (The figure does not show trees that are further away from the right-of-way.)

Looking west on Route 2 towards an arborvitae hedge on the south side of the road at the edge of the right-of-way.
